Site Reconnaissance and Construction Recommendations
for the Coos County Natural Gas Pipeline
Project

GEOTECHNICAL ENGINEERING REPORT **Route Reconnaissance and Construction Recommendations for the Coos** **County Natural Gas Pipeline Project**

FOR: Coos County Board of Commissioners, Coquille, Oregon

DATE: November 28, 2001

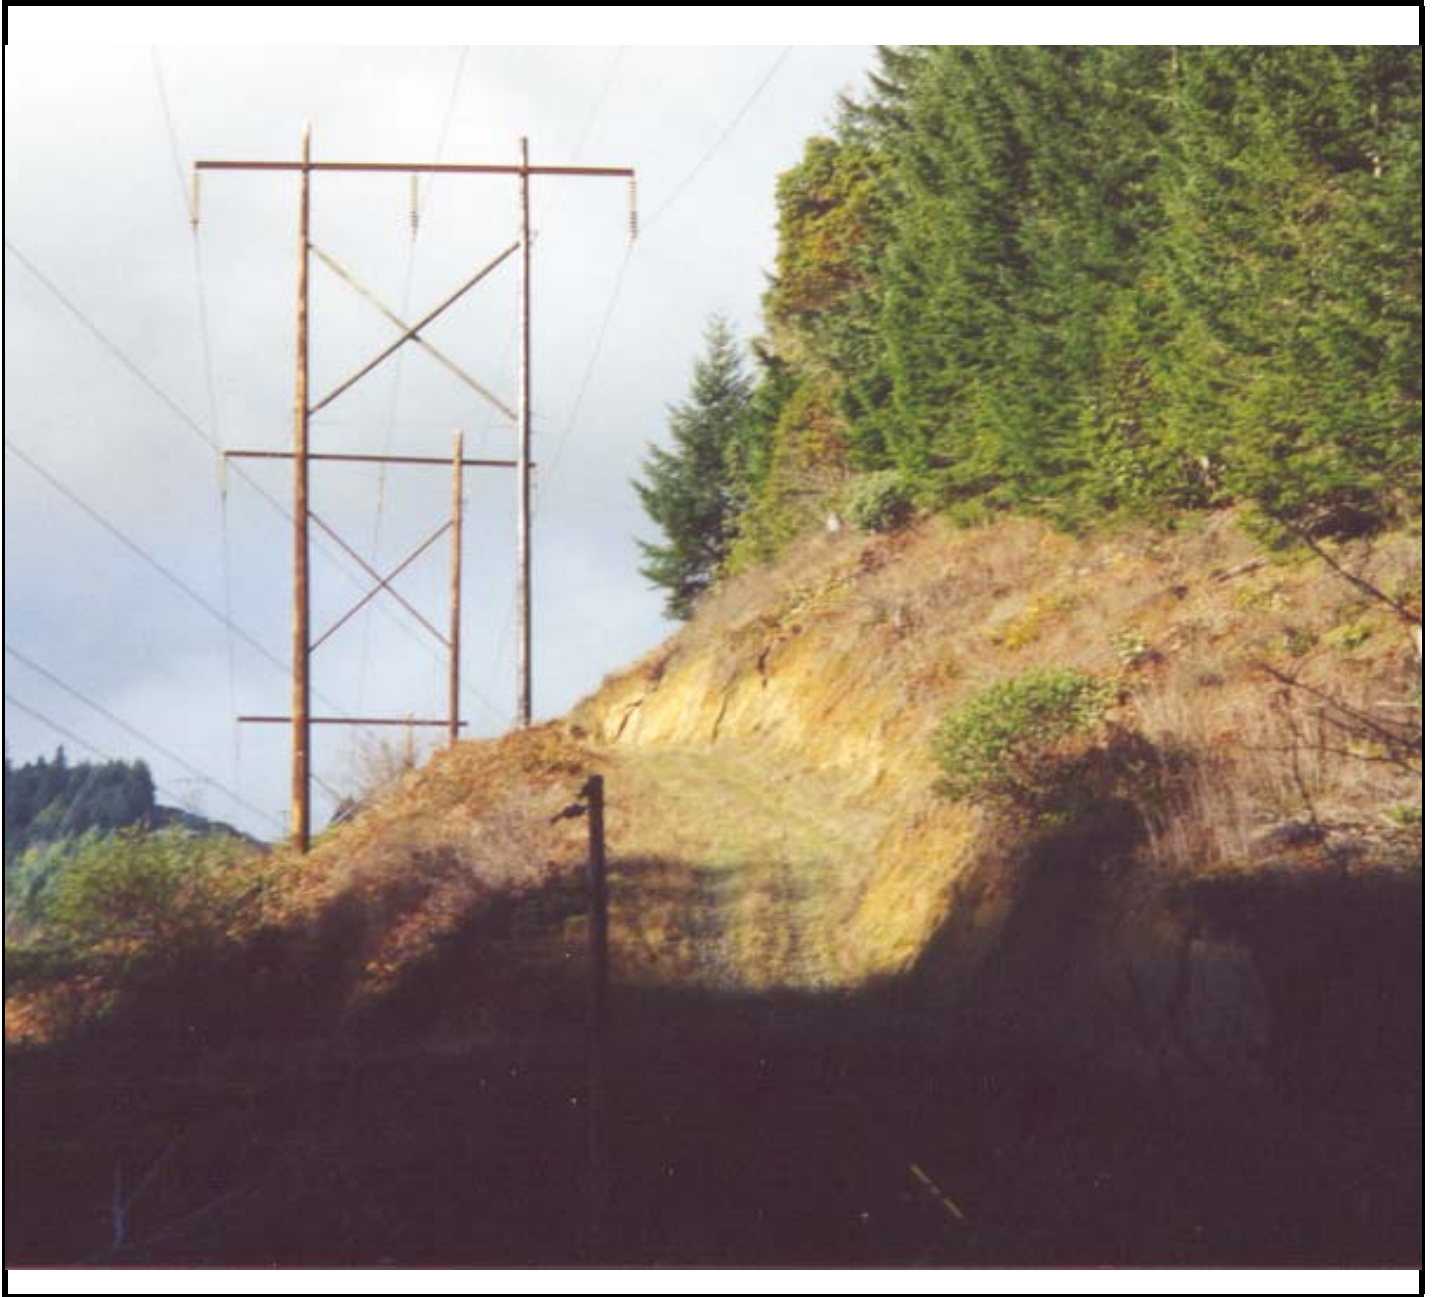
1. **Sideslope Construction.** Along several locations, the BPA power line was constructed on relatively steep sideslopes, illustrated by Figure A-2. Since pipeline construction equipment will require a reasonably level working space of 25 to 30 feet wide, as much as 60 feet in width will be required to allow excavation and leveling of the work area. Except for minor impacts on schedule, this feature does not present unusual complexity.
2. **Steepness of Slopes.** The heavily eroded ridge and valley ground surface along the route from Reston to Dora has resulted in very steep slopes with large elevation differences between the ridge top and valley bottom. Steep slopes reaching, and occasionally exceeding, 20 percent grade exist along the sections of the pipeline originally proposed to be placed in the BPA power line ROW. This is illustrated in Figure A-3.

Figure A-2. View of BPA powerline on steep hillside at Mile 10 on CBW Road.

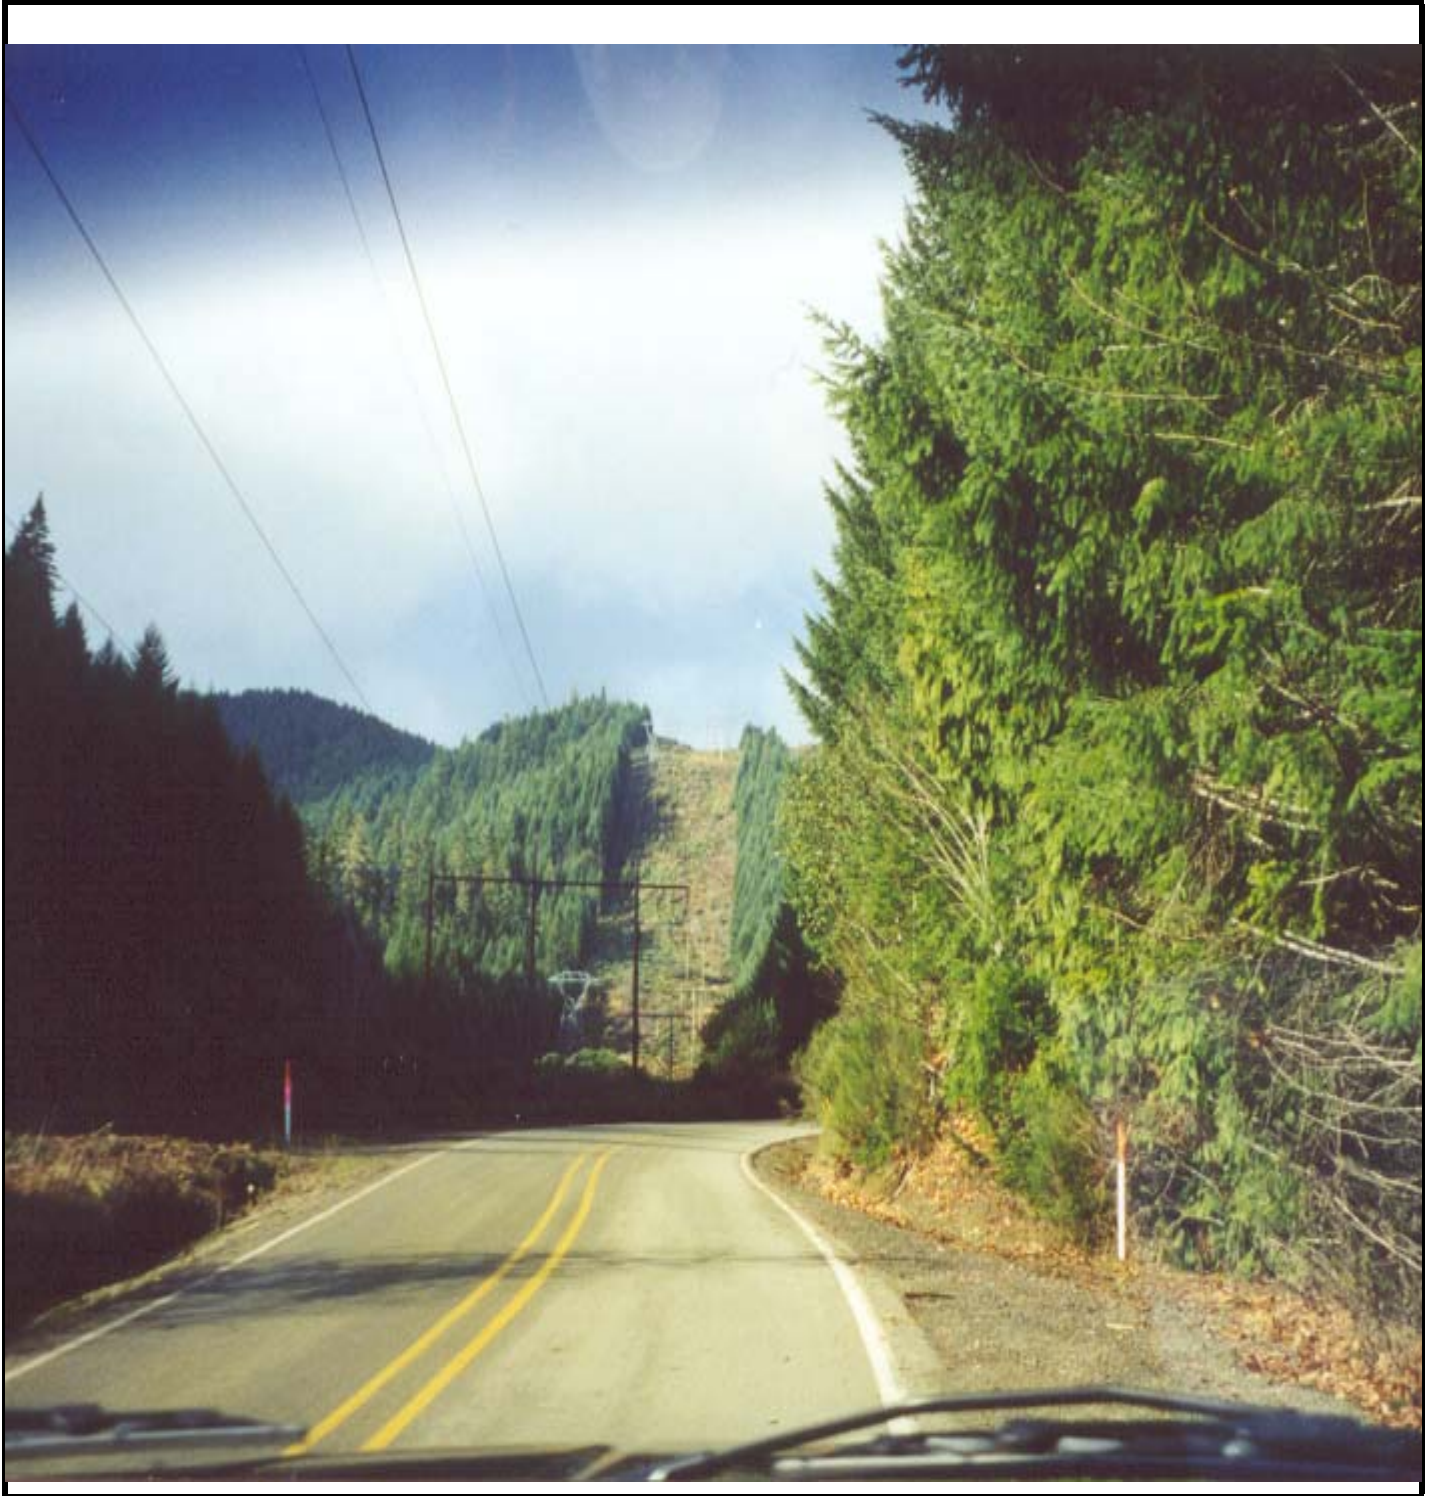
Figure A-3. Rise of BPA powerline up steep 20 percent slope at Mile 13 on CBW Road

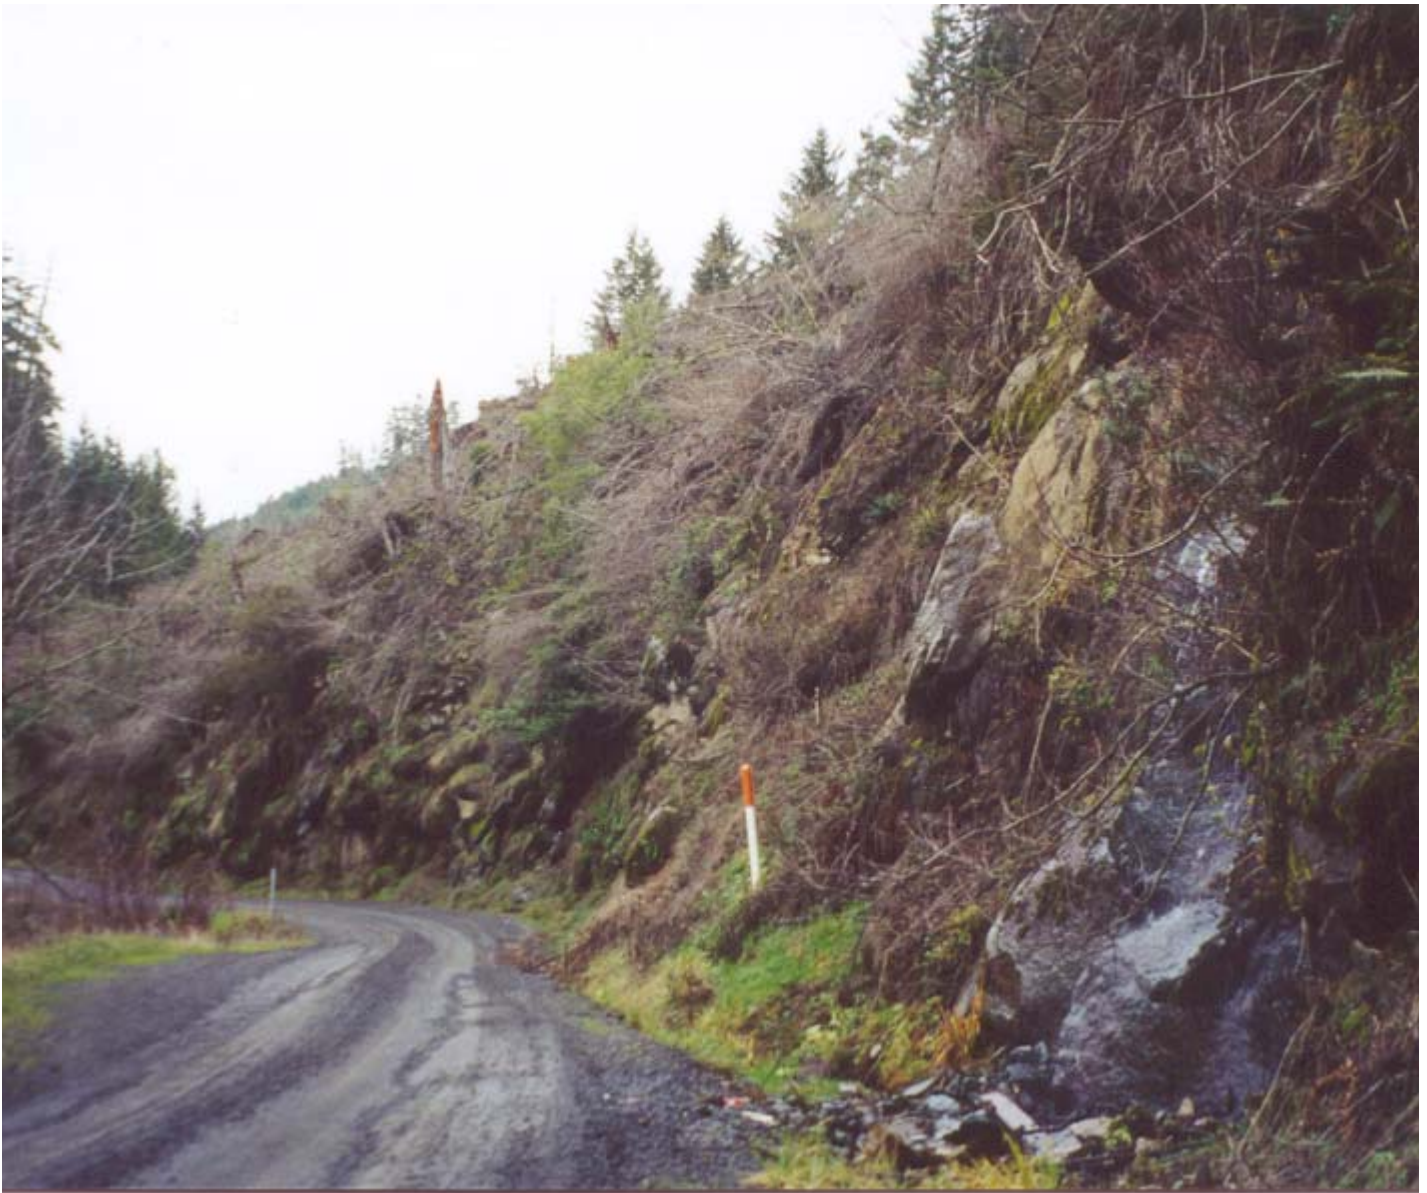
Figure A-4. View along Brewster Canyon at Mile 21 on CBW Road. Left side of road leads down at steep angle to the East Fork of the Coquille River

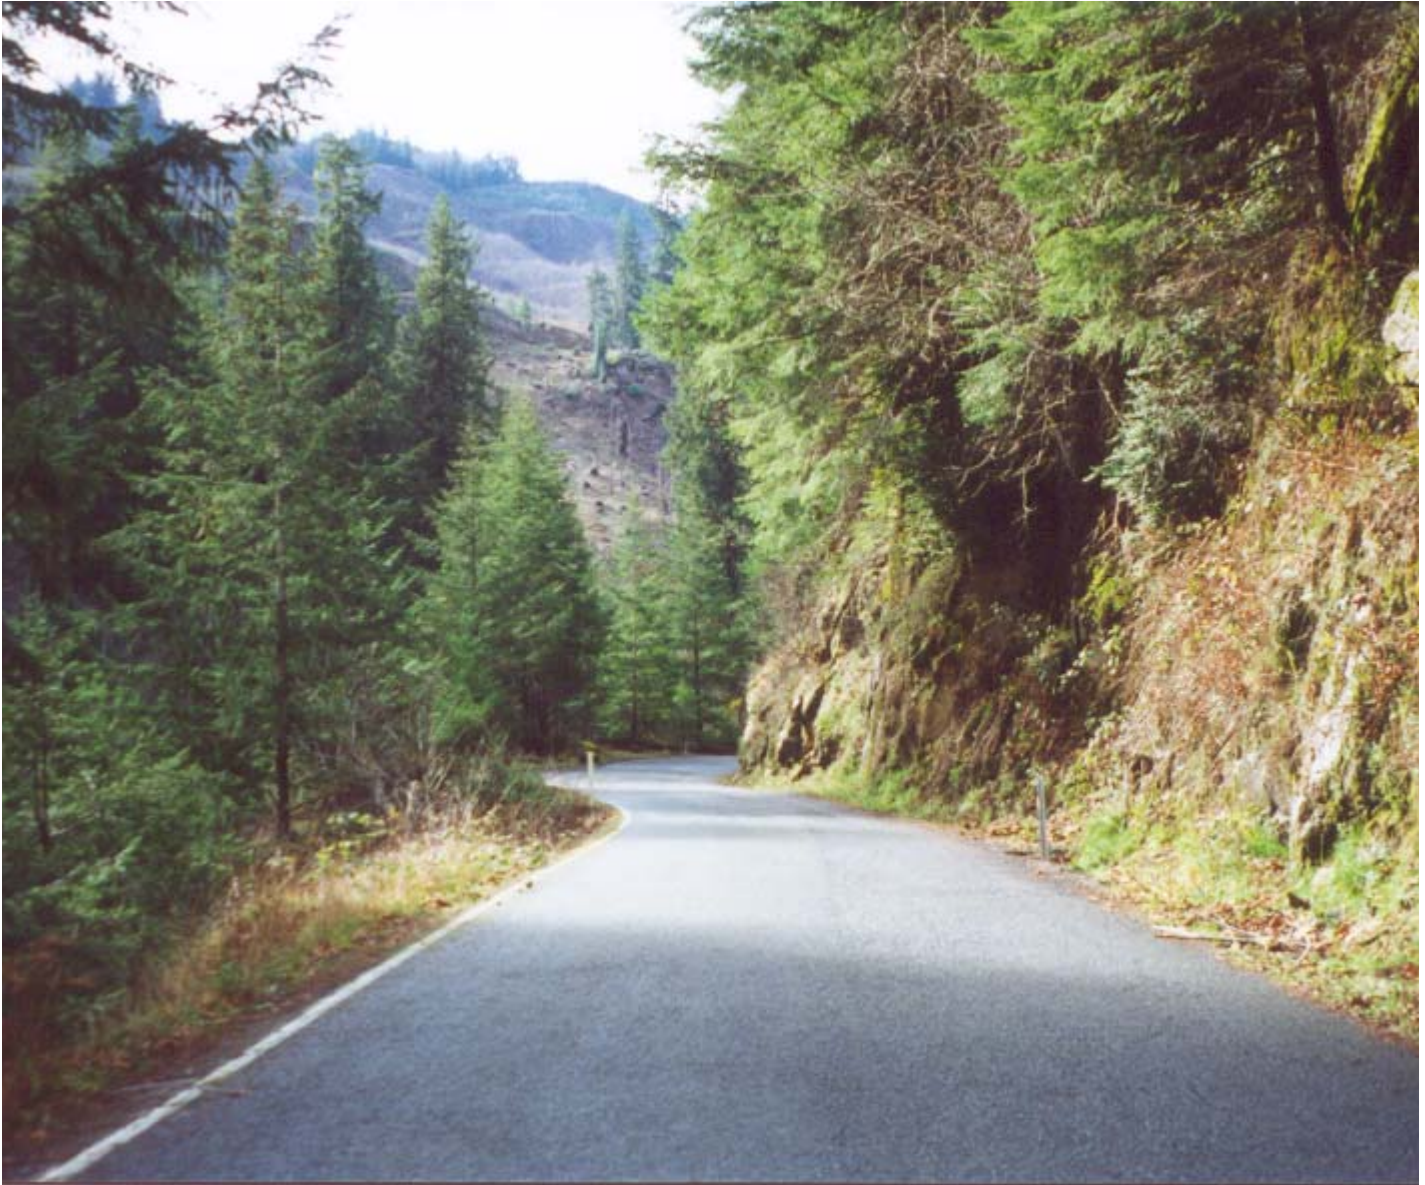
Figure A-5: View Along Brewster Canyon on CBW Road.
